Lane Community College Building 18

Sustainability Report

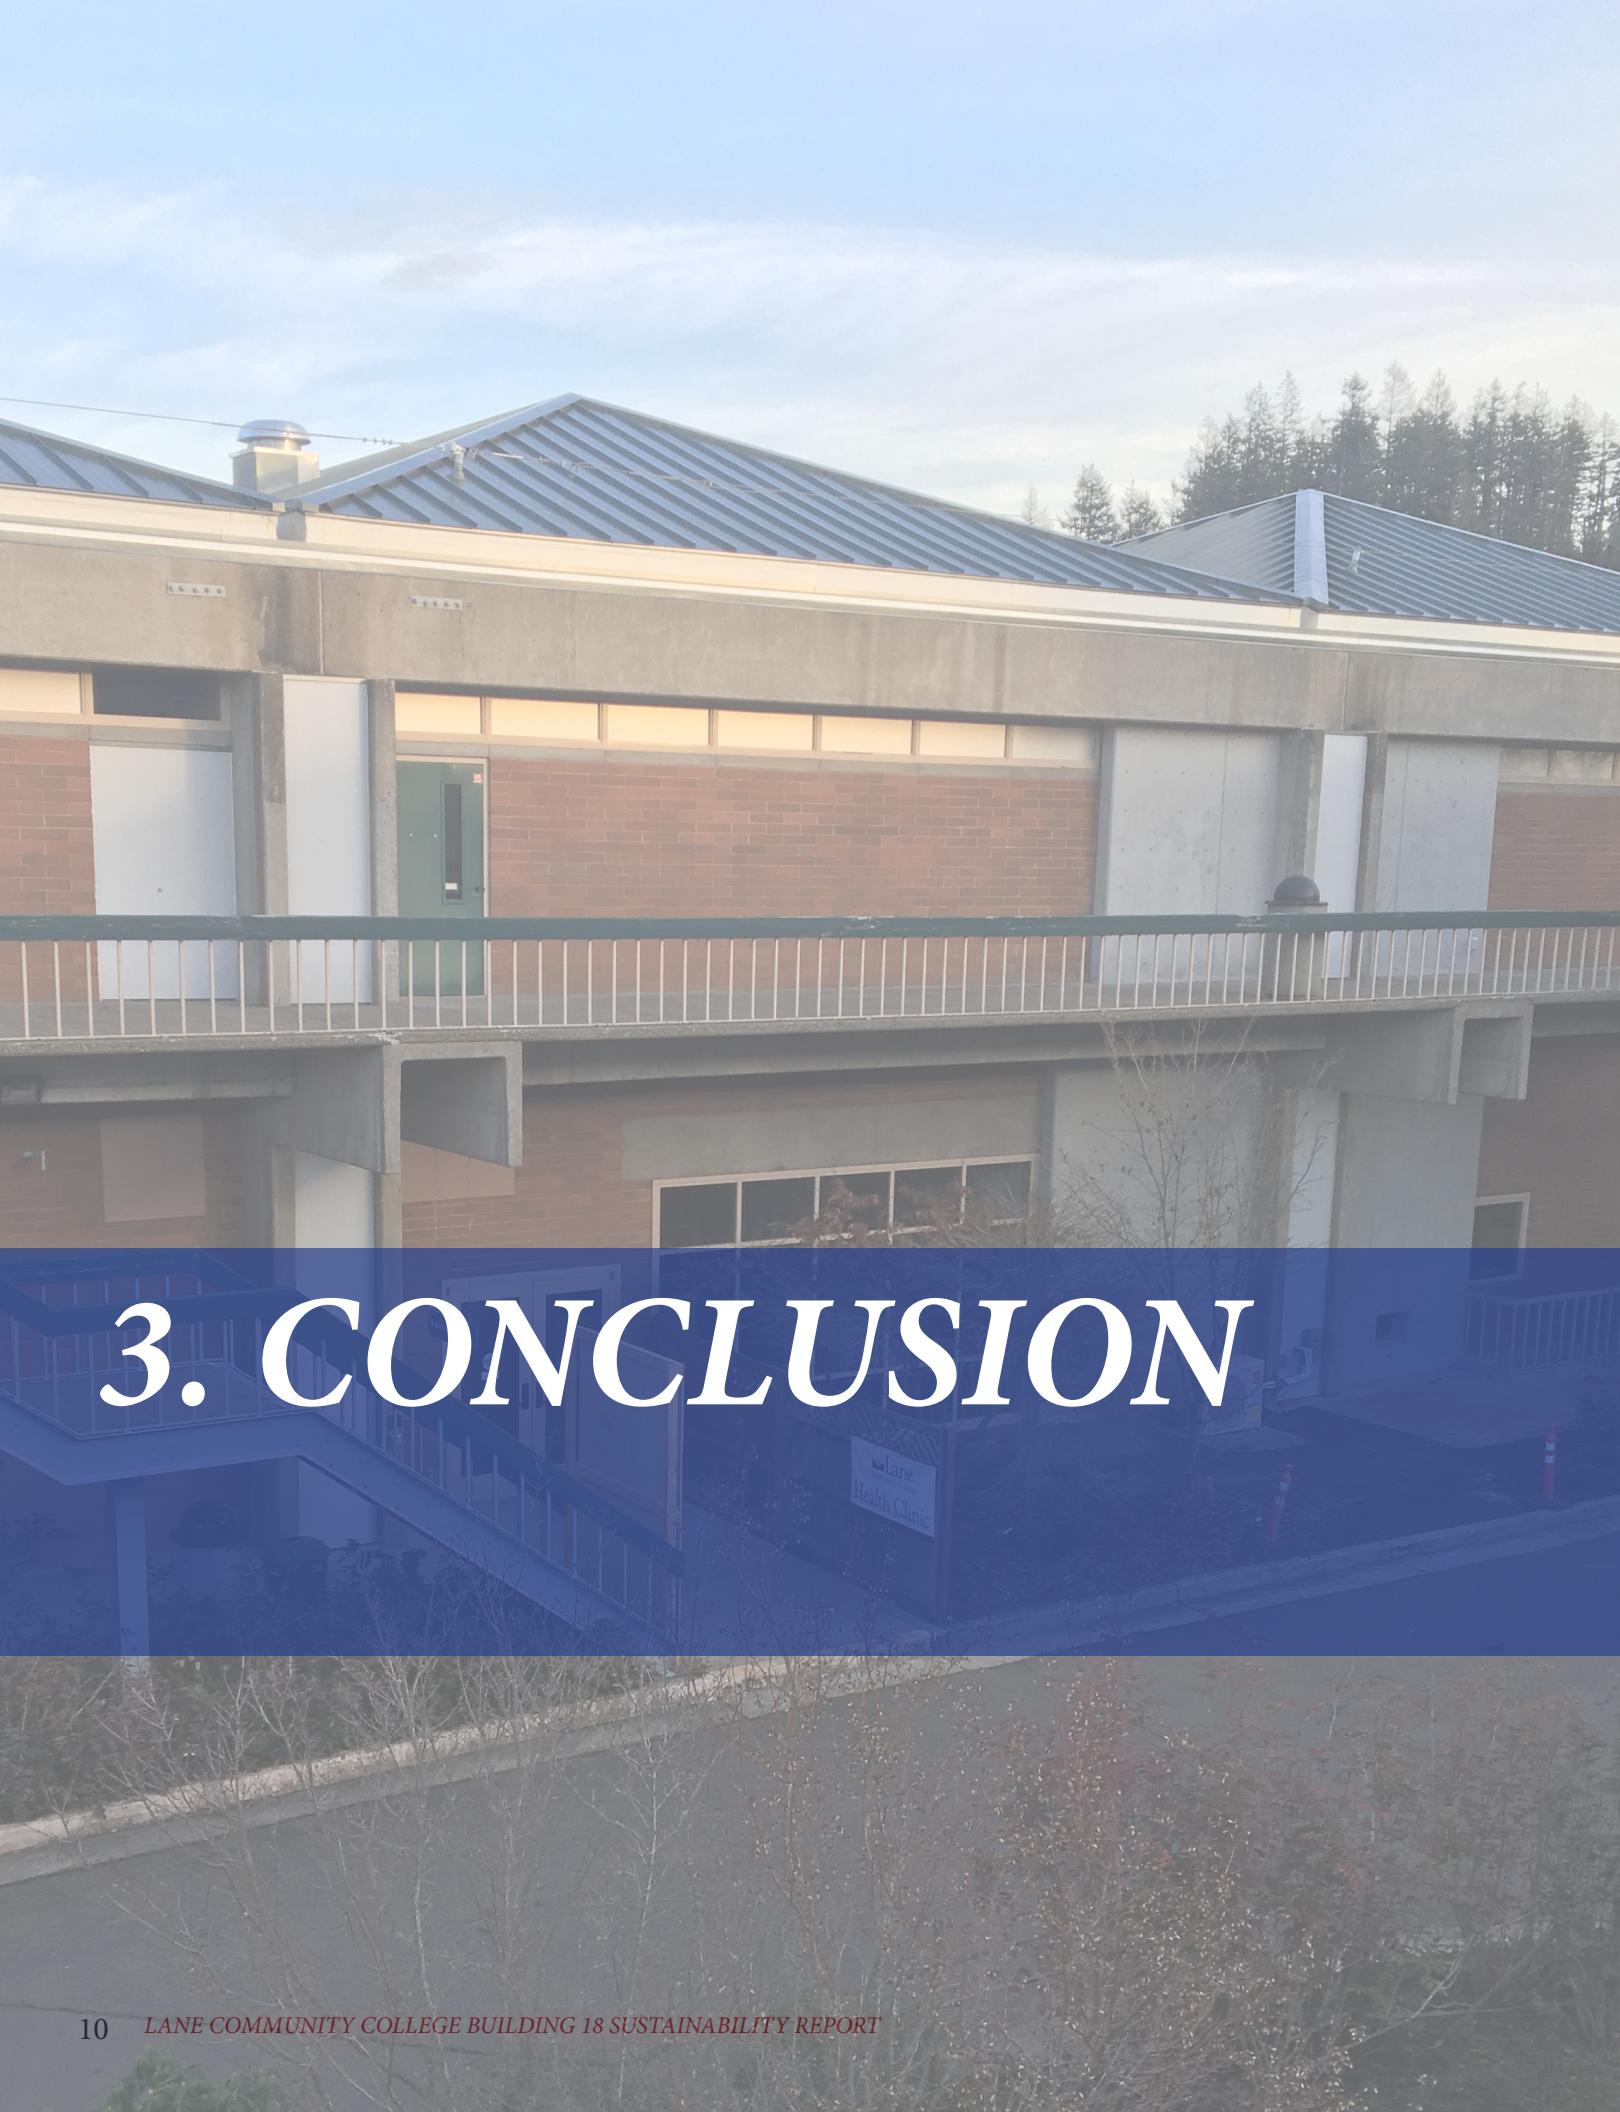
A photograph of a modern two-story building with a light-colored concrete facade and a red brick section. The building features a balcony with a white railing on the upper level. A green door is visible on the left side. The roof is made of dark grey metal panels. In the foreground, there's some bare trees and a paved area. The sky is clear and blue.
